**TOWN OF WASAGA BEACH**

**WASAGA STARS ARENA &  
RECREATION CAMP**

**STRUCTURAL & BUILDING  
ASSESSMENT / AUDIT**

SEPTEMBER 30, 2013

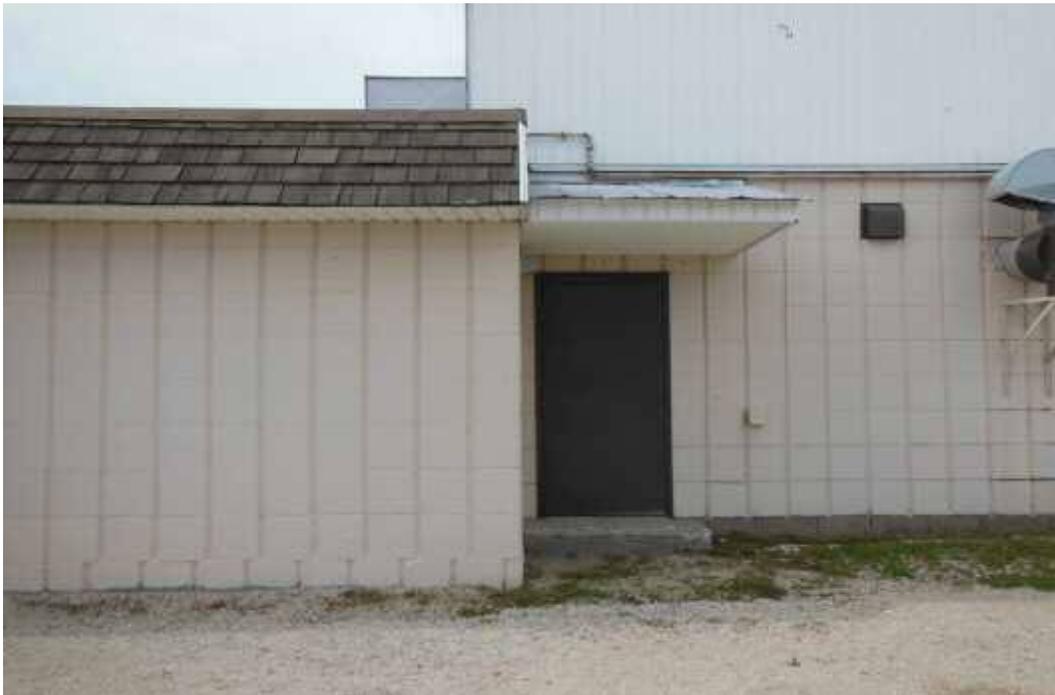
Photo 3 – Existing Exit Door at South Side of Building

- stair riser heights are not consistent (range from 6.5" to 9") and tread lengths are equally inconsistent (range 9.5" to 12"). This poses a trip hazard to users; reconfiguration is recommended,
- the height of the handrails are not consistently at 36" above the nosing line, nor do they extend a minimum of 12" beyond the top and the bottom risers; replacement is recommended;

- OBC demands a minimum of 6'-9" to the underside of any structure inside a stairwell; the existing lower bulkhead is only 6'-0". This poses a hazard to persons using the exit; recommend adjusting the clearance height accordingly,

- the leading edge of each tread (at the nose) must be demarked with a dissimilar material and have non-slip properties. Recommend installing purpose made, coloured, industrial non-slip 'grit' tape, minimum 1" wide x entire width of each tread.

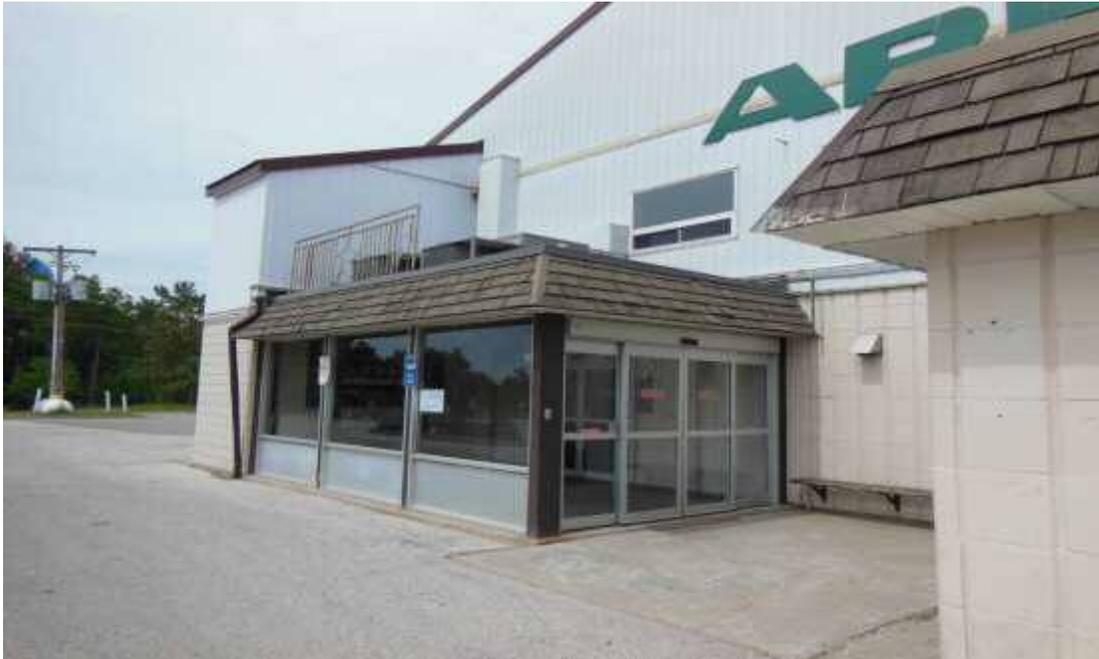
Photo 4 – Main Entry Vestibule (West Side of Building)

The Main Entrance Vestibule consists of glass walls and lightly insulated spandrel panels. The roof currently experiences ongoing water infiltration (sometimes to the extreme); water has been noticed running down the windows and running down the roof/wall joint over the interior sliding door area. Refer to Photo 4.

Recommended work items for the roof replacement can be considered as priority #1, with the balance of work items as priority #3:

- remove unrated (abandoned) ticket booth opening, or, provide 45-minute rated shutter door assembly,
- several HVAC mechanical ducts penetrate thru the stairwell area of this Entry space; recommend that 45-minute fire-rated dampers be installed at all locations where ducts penetrate the perimeter walls of this area,
- life span of the flat roof provided over the Main Entry including all related flashing details have been surpassed. In order to properly eliminate water infiltration, it is recommended that the existing rooftop HVAC units be temporarily removed, remove all existing flashings and roofing, provide new flashing, provide a new built-up roof assembly, counter flash, make water-tight, reinstall the RTU assemblies, and make good (priority #1).

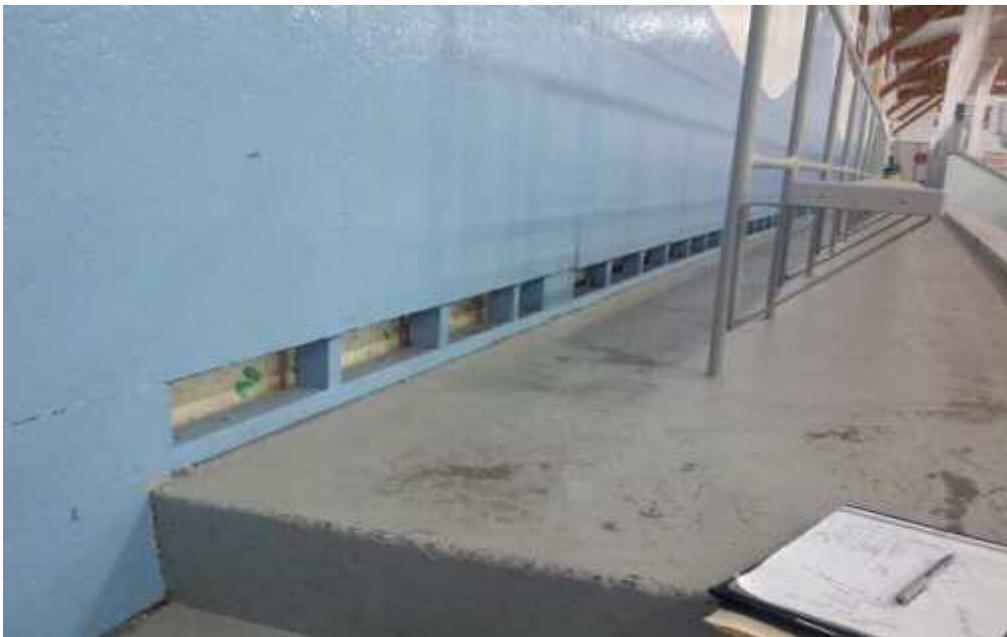
Photo 5 – Spectator Seating / Standing Area (North Side)

The interior of the ice rink area is well kept and clean with newly covered plastic seating benches, and a new barrier-free ramp provided along the South side of the ice to allow for two (2) wheelchair spaces for viewing. The location and design of the steel pipe hand-rail that is provided along both the North & South sides of the ice surface (used to delineate the standing room from the seating area), is very small with little to no room for persons to pass by anyone standing at the rail. In its current condition, there is inadequate aisle width to ensure this is an entirely safe situation. Refer to Photo 5.

- stairs accessing the tiered seats and the standing room upper railing are not Code Compliant; riser heights are far too high, and without adjacent handrails makes using these steps extremely awkward. This no physical space to allow a remedy for this problem,
- trip hazards exist at some of the 4 available exit doors,
- ensure all 4 exit signs are properly illuminated,
- some exit doors require door sills, new sweeps and weather stripping,
- there is an adequate number of exit doors to serve the maximum calculated occupant load of 512 persons,
- handrails to the steps/stairs on the West end of the spectator seating area require complete replacement in order to meet OBC requirements,

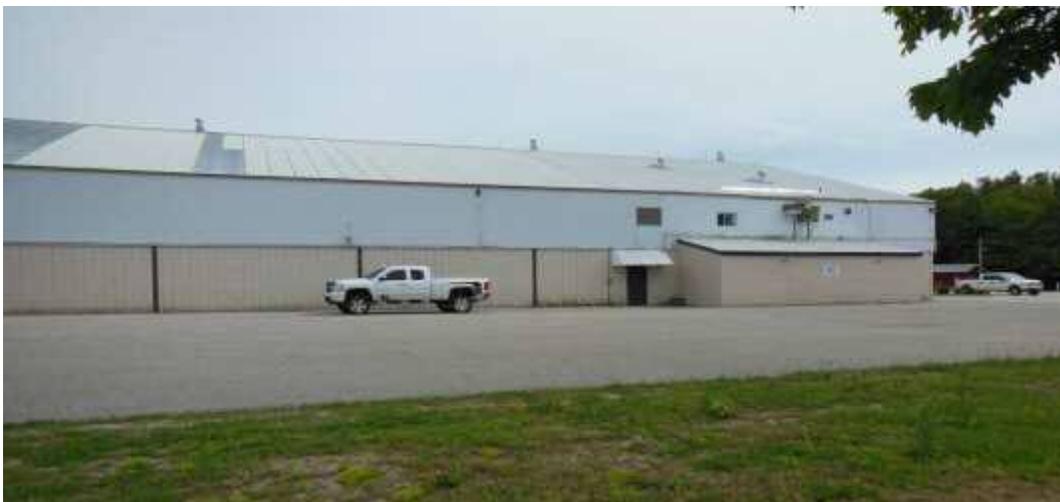
Photo 6 – Standing Seam Metal Roofing (North Side of Arena)

The Wasaga Stars Arena building consists of 10'-0" high exposed concrete block (8" thick), topped with 10'-0" high pre-finished metal (or vinyl) siding. A number of roof types are present on the single storey additions – built-up tar & gravel roofing over precast concrete roof slabs for Dressing Room Nos. 5 & 6, built-up tar & gravel roofing supported by wood decking and timber glulam support beams for the Main Entry Vestibule, standing seam metal roofing for the expansion of Dressing Room Nos. 1 & 2. The main roof over the Rink Surface and second level Auditorium consists of standing seam metal roofing (galvalume finish), some of which has been covered with a spray-on water-proofing membrane (ie. roof over the 2-storey portion – west end of building). Portions of the sloped standing seam roofing (directly over the arena) is displaying rust at the top seam area. Refer to Photo 6.

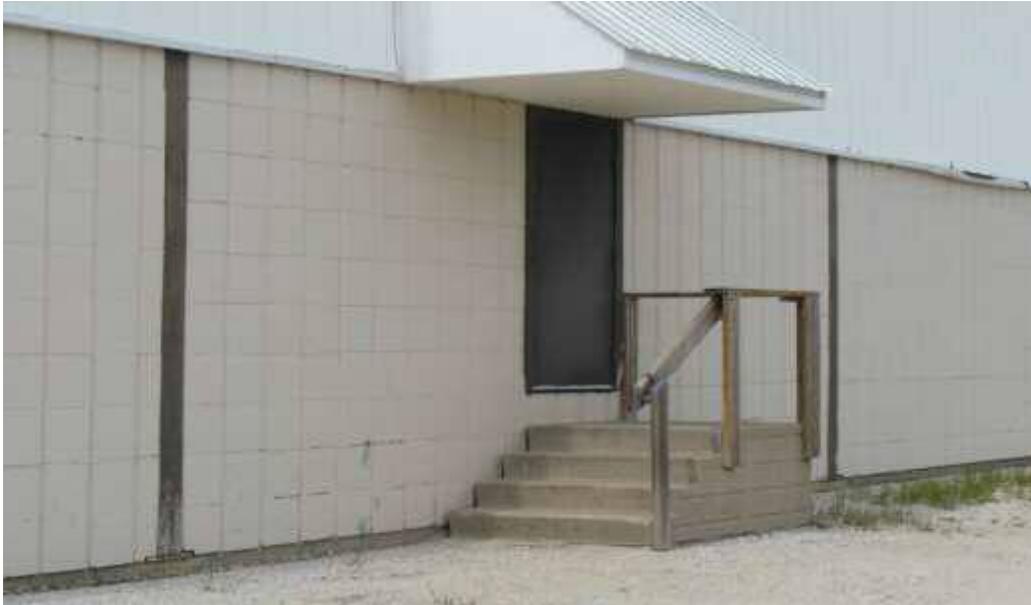
Photo 8 – Exterior Exit Door (South Side of Arena)

5. Two of the exit doors on the North and South sides of the rink (ie. east end of rink) exit out onto a precast stoop and step. The guards and rails on these stoops/steps must be entirely replaced with Code compliant guards and rails. Refer to Photo 8. Strongly suggest that exterior lights be added above the stoops/steps to illuminate the exit stair assembly - priority #1,

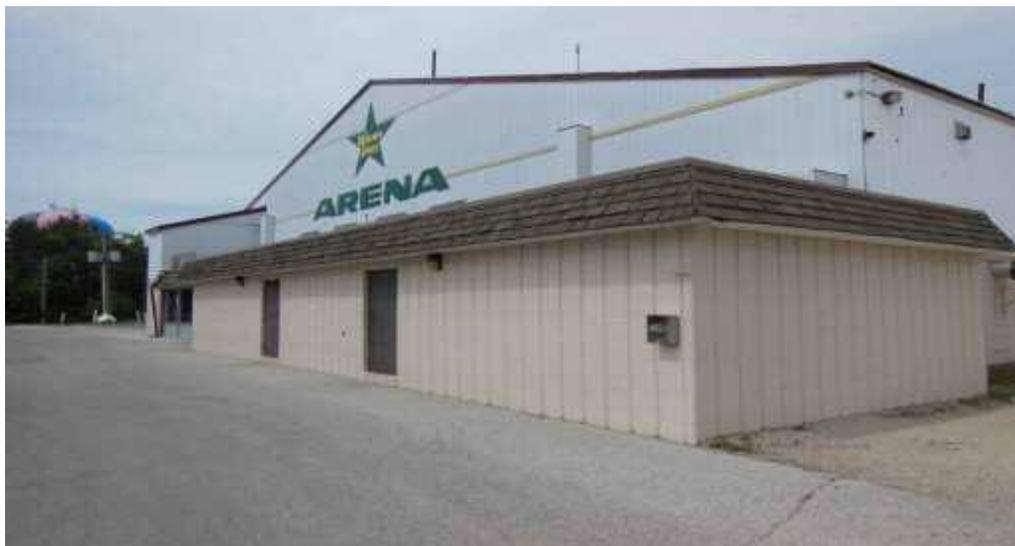
Photo 9 – Exit Doors for Dressing Room Nos. 5 & 6 (West Side)

7. Protect exit doors from Dressing Rooms 5 & 6 from passing vehicle damage - remedy with protective painted steel bollard units. Refer to Photo 9. Replace sill, sweep and weather stripping - priority #1,

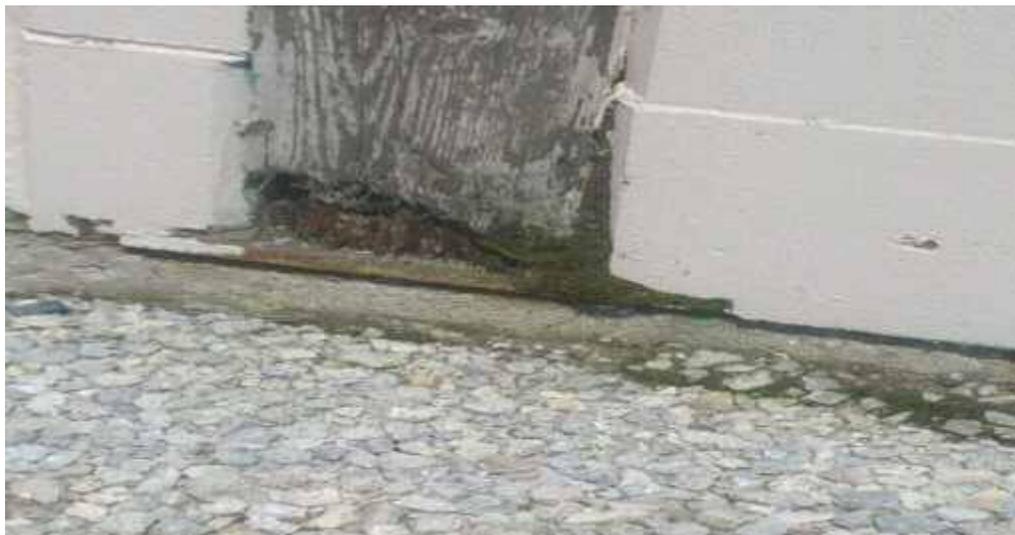
Photo 10 – Exposed Timber Columns ( North & South Sides)

12. Structural timber support columns / posts (support of timber roof trusses) are exposed to the elements along the North and South building faces. Some of the timber columns are showing signs of significant deterioration (*refer to Photo 9*). If left exposed, structural damage and deterioration will persist - priority #1.

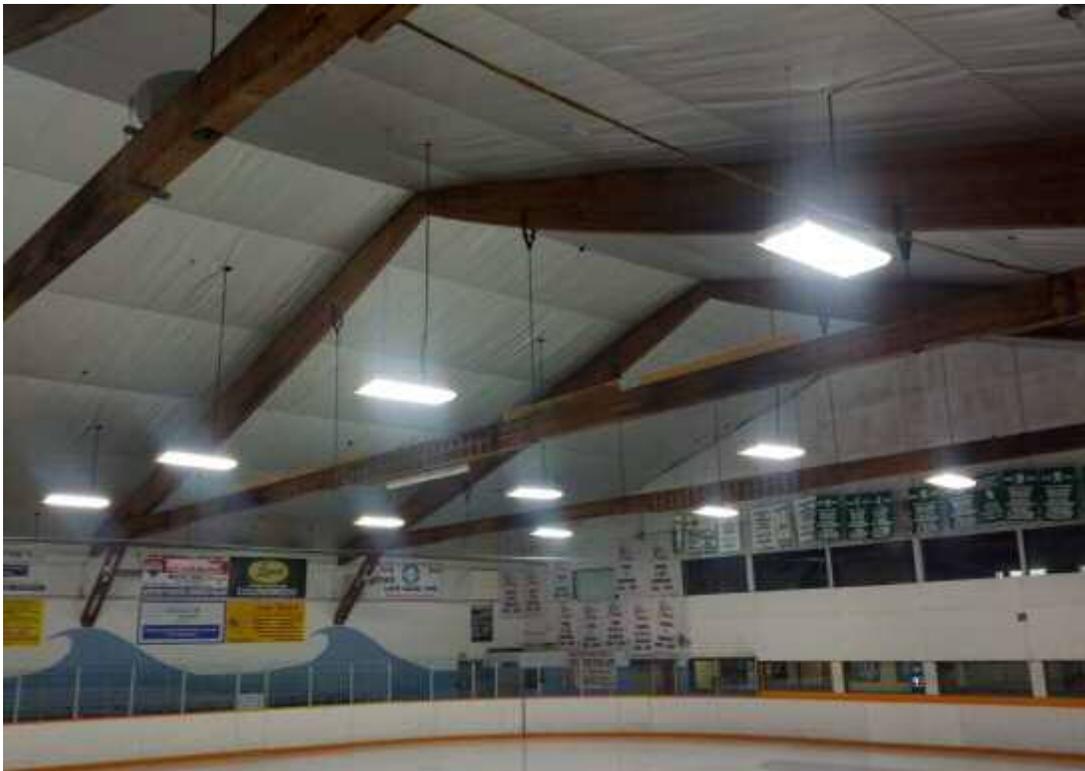
Photo 11 – Existing Timber Roof Trusses (Ice Surface)

The roof structure over the ice surface and second floor Auditorium (ie. 2 storey portion) consists of timber frame roof trusses, spaced every 24'-0" on centre complete with 5"x 14 1/2" Douglas fir roof purlins spaced every 4'-0" on centre. The roof assembly consists of 2 x 6 exposed roof decking (Douglas fir) and standing seam metal roofing (galvalume finish) over. It is unknown where there is any insulation between the wood decking and the standing seam metal roofing. Based on our review of other building components (ie. exterior wall assembly), it is likely that there is no insulation within the roof assembly.

A visual inspection was performed by the undersigned on the existing timber frame roof trusses. Based on our visual inspection (no destructive testing performed during this site review), the timber frame trusses, roof purlins and support columns were found to be dry and in good condition throughout. There were no signs or indications of delamination, cracks, splintering or rot; minor checking was noted on some of the timber members but considered to be of no structural significance. The effects of the previous reported moisture problems (ie. water stains, discoloration and adhered dust on the surface of the timber members, as noted in a previous structural inspection report prepared by Ainley & Associates) is still evident.

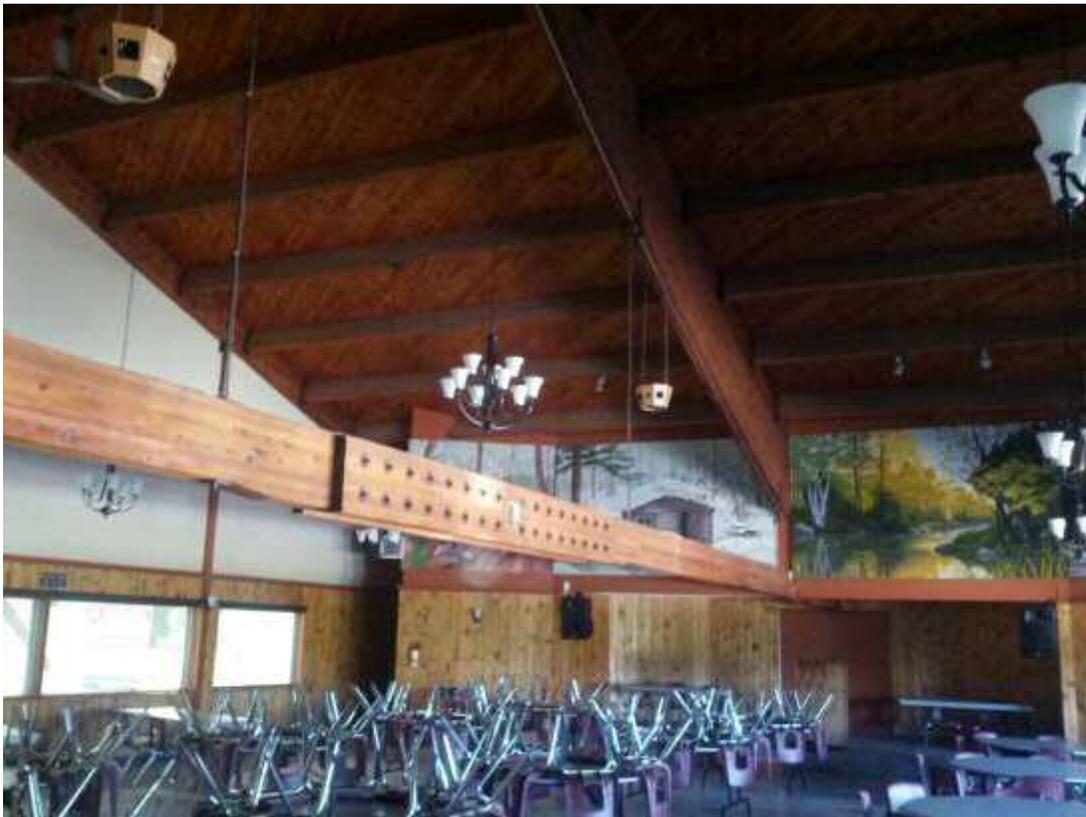
Photo 12 - Existing Timber Roof Trusses (Upper Level Hall / Auditorium)

However, it is noted that a new Desicon dehumidification system was installed within the rink area by Cimco Refrigeration in 2006, replacing the old dehumidifiers. The result is a significant reduction in the moisture content measured in the timber frame trusses over the ice surface. Surface corrosion was observed on the majority of the steel components including most of the exposed fasteners (bolts & washers), connection plates, brackets and beam saddles. This condition was typical on all exposed fasteners and metal components provided on the timber frames over the ice surface. In the previous structural report prepared by Ainley & Associates Limited (report dated June 09, 2009), it was recommended that all corroded structural fasteners and steel plates be cleaned with a wire brush and coated with a rust inhibitive paint. Based on our review, it would appear that this work has not been completed.

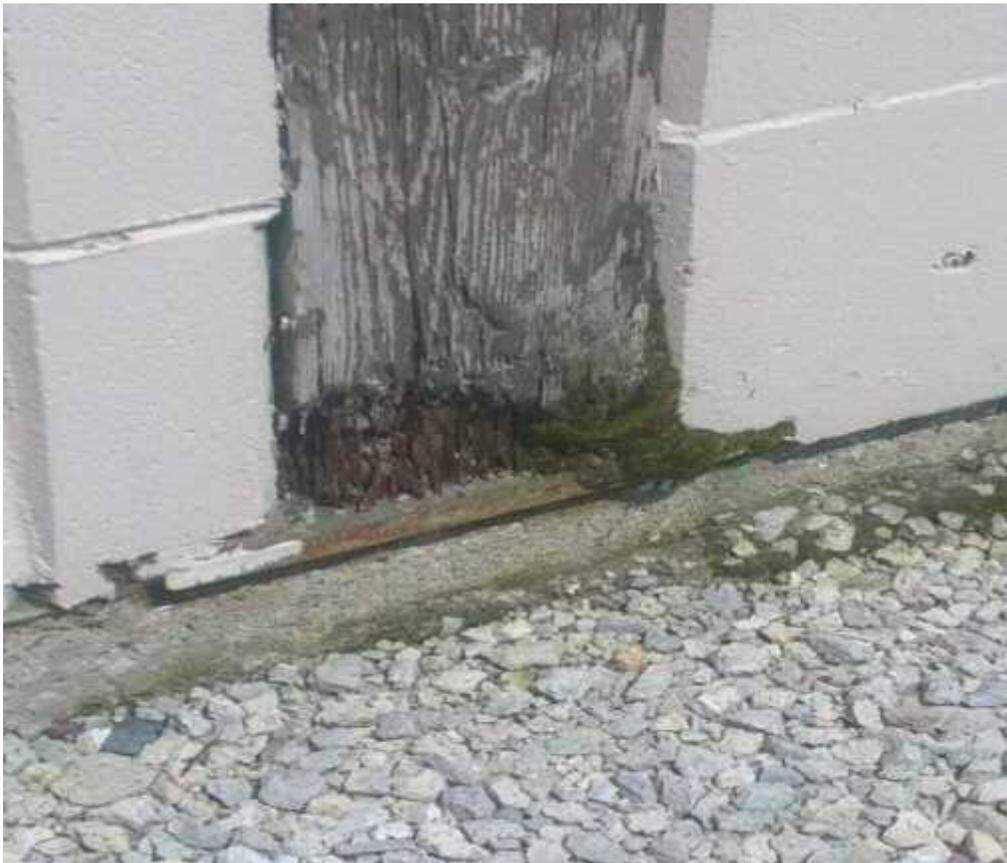
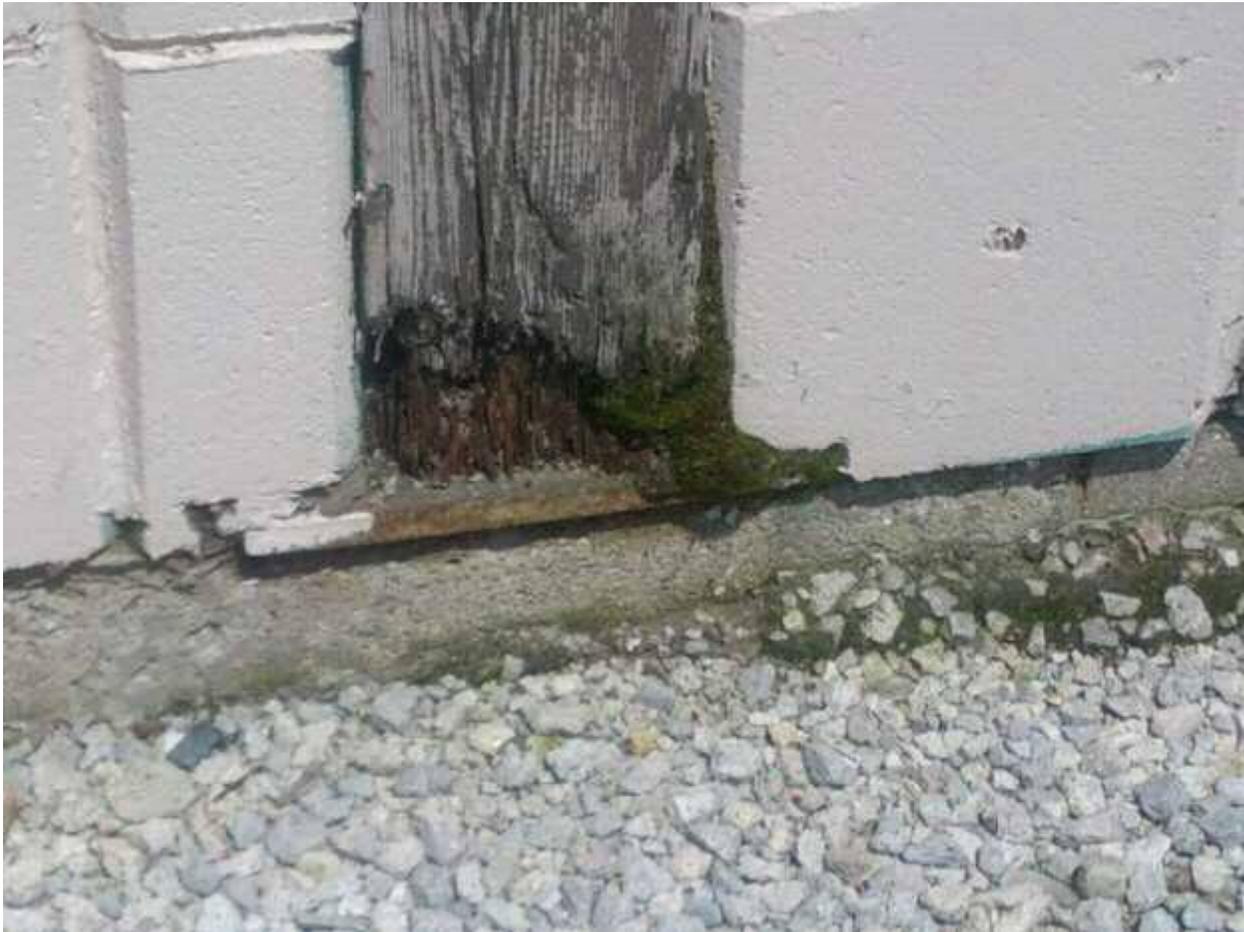
During inspection of the building exterior, it was noted that the timber columns that provide structural support of the timber-frame roof trusses are located within the exterior block walls of the building (ie. north & south sides of the building); it is noted that these support columns are exposed to the weather. Based on comments provided in a previous structural inspection report (prepared by Ainley & Associates Limited, dated September 22, 2004), it was noted that these exposed timber columns were originally covered with metal flashing and it was recommended by Ainley & Associates that this flashing be removed from the base of the

columns, since the metal flashing effectively trapped moisture between the metal flashing and the timber column. In addition, it was recommended that the base of these exposed columns be coated with a creosote based wood preservative.

Based on discussions with Phil Eichler (Facilities Foreman, Town of Wasaga Beach), it is my understanding that this work was completed by arena staff in or around 2005. At the time of our inspection, there is evidence of rot and deterioration at the base of these timber columns (where the timber columns bear on the perimeter foundation wall). It appears that the creosote based wood preservative is no longer present on the timber columns provided on the south side of the building, likely the result of long term UV damage. However, the observed deterioration appears to be worst along the north side of the building where the asphalt pavement extends up tight to the perimeter foundation wall (ie. level with the top of the foundation wall). Based on my review, there are some locations where the observed dry rot and deterioration is of structural significance. It is important to note that the observed deterioration at the base of these timber columns will eventually result in a reduction in the structural load-carrying capacity of these timber support columns.
