# **WASAGA SHORES SUBDIVISION**

## **Town of Wasaga Beach**

### **Shoreline Hazard Study**

1428420 Ontario Inc.  
November 15, 2018  
CCTA File 116028

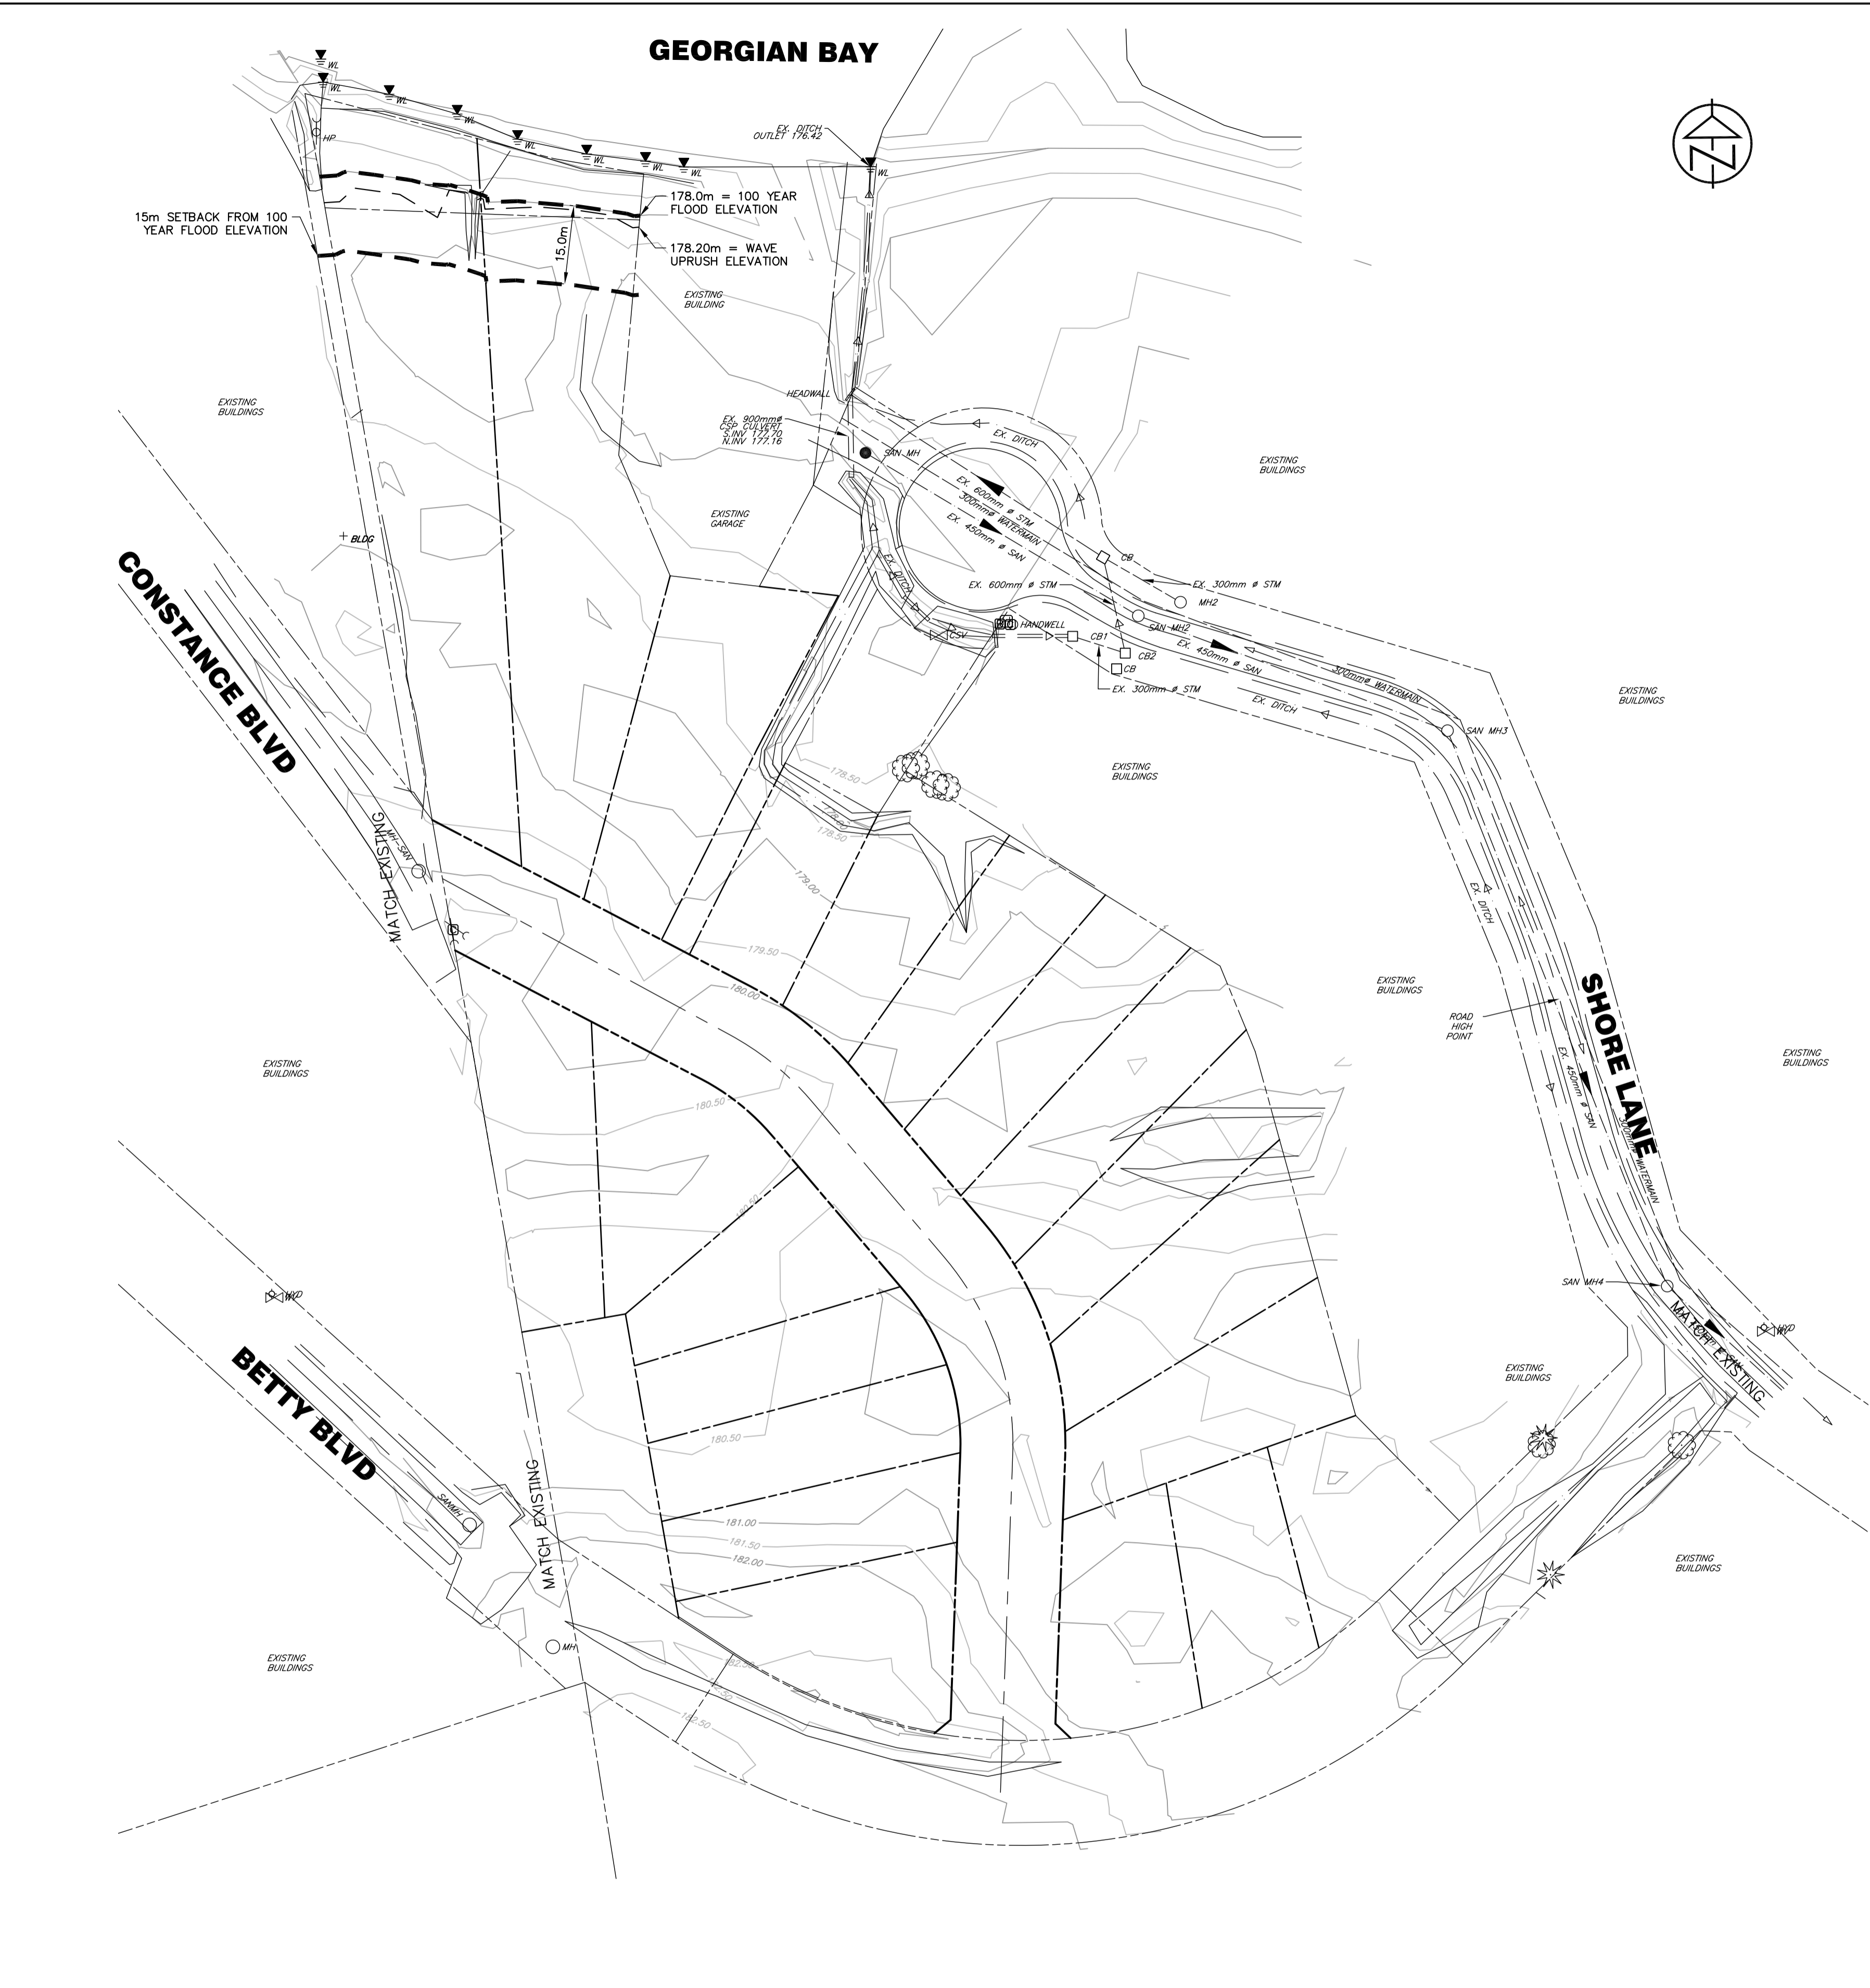
DWG. **HAZ-1**

The hazard limits and proposed setbacks are shown on **Drawing HAZ-1**.

All proposed building envelopes are to be located outside the shoreline hazard limit, as shown in **Drawing HAZ-1**. The shoreline hazard setback is to be enforceable as a provision of the by-law.

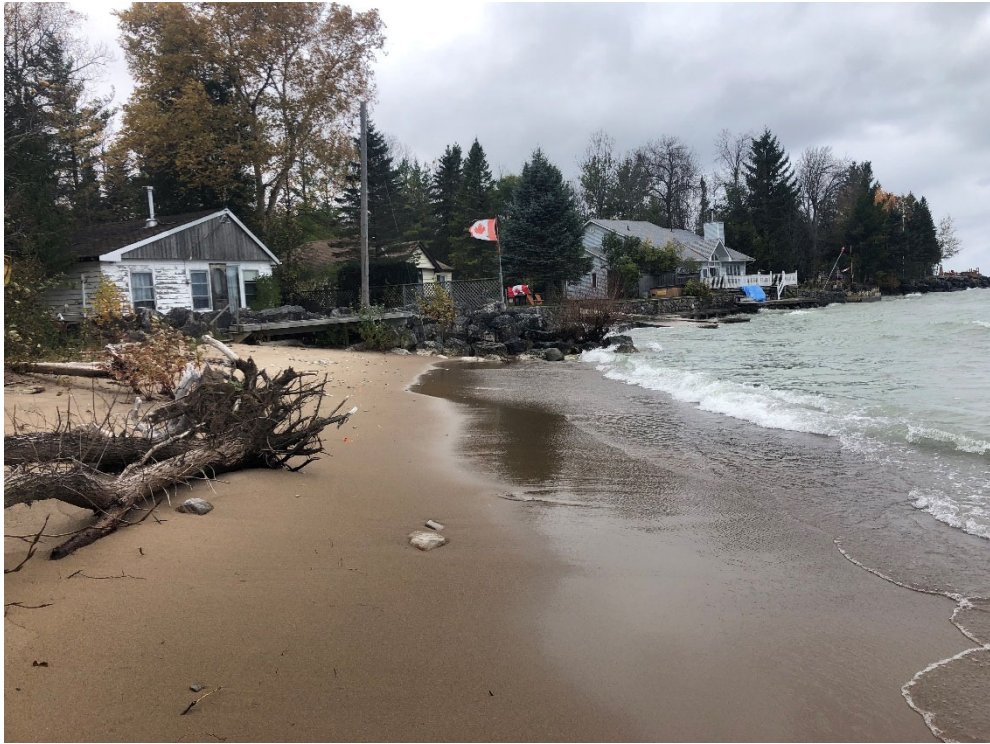
**Photograph 1: Existing Shoreline Facing North West**

The property is located on Georgian Bay. The site is exposed to waves generated from the northwest-north-northeast directions. The subject shoreline is a sand beach that transitions to mature vegetation further from shore, at a slope of approximately 2.0%. A series of cobble/boulder shoreline revetments exist on neighbouring properties.

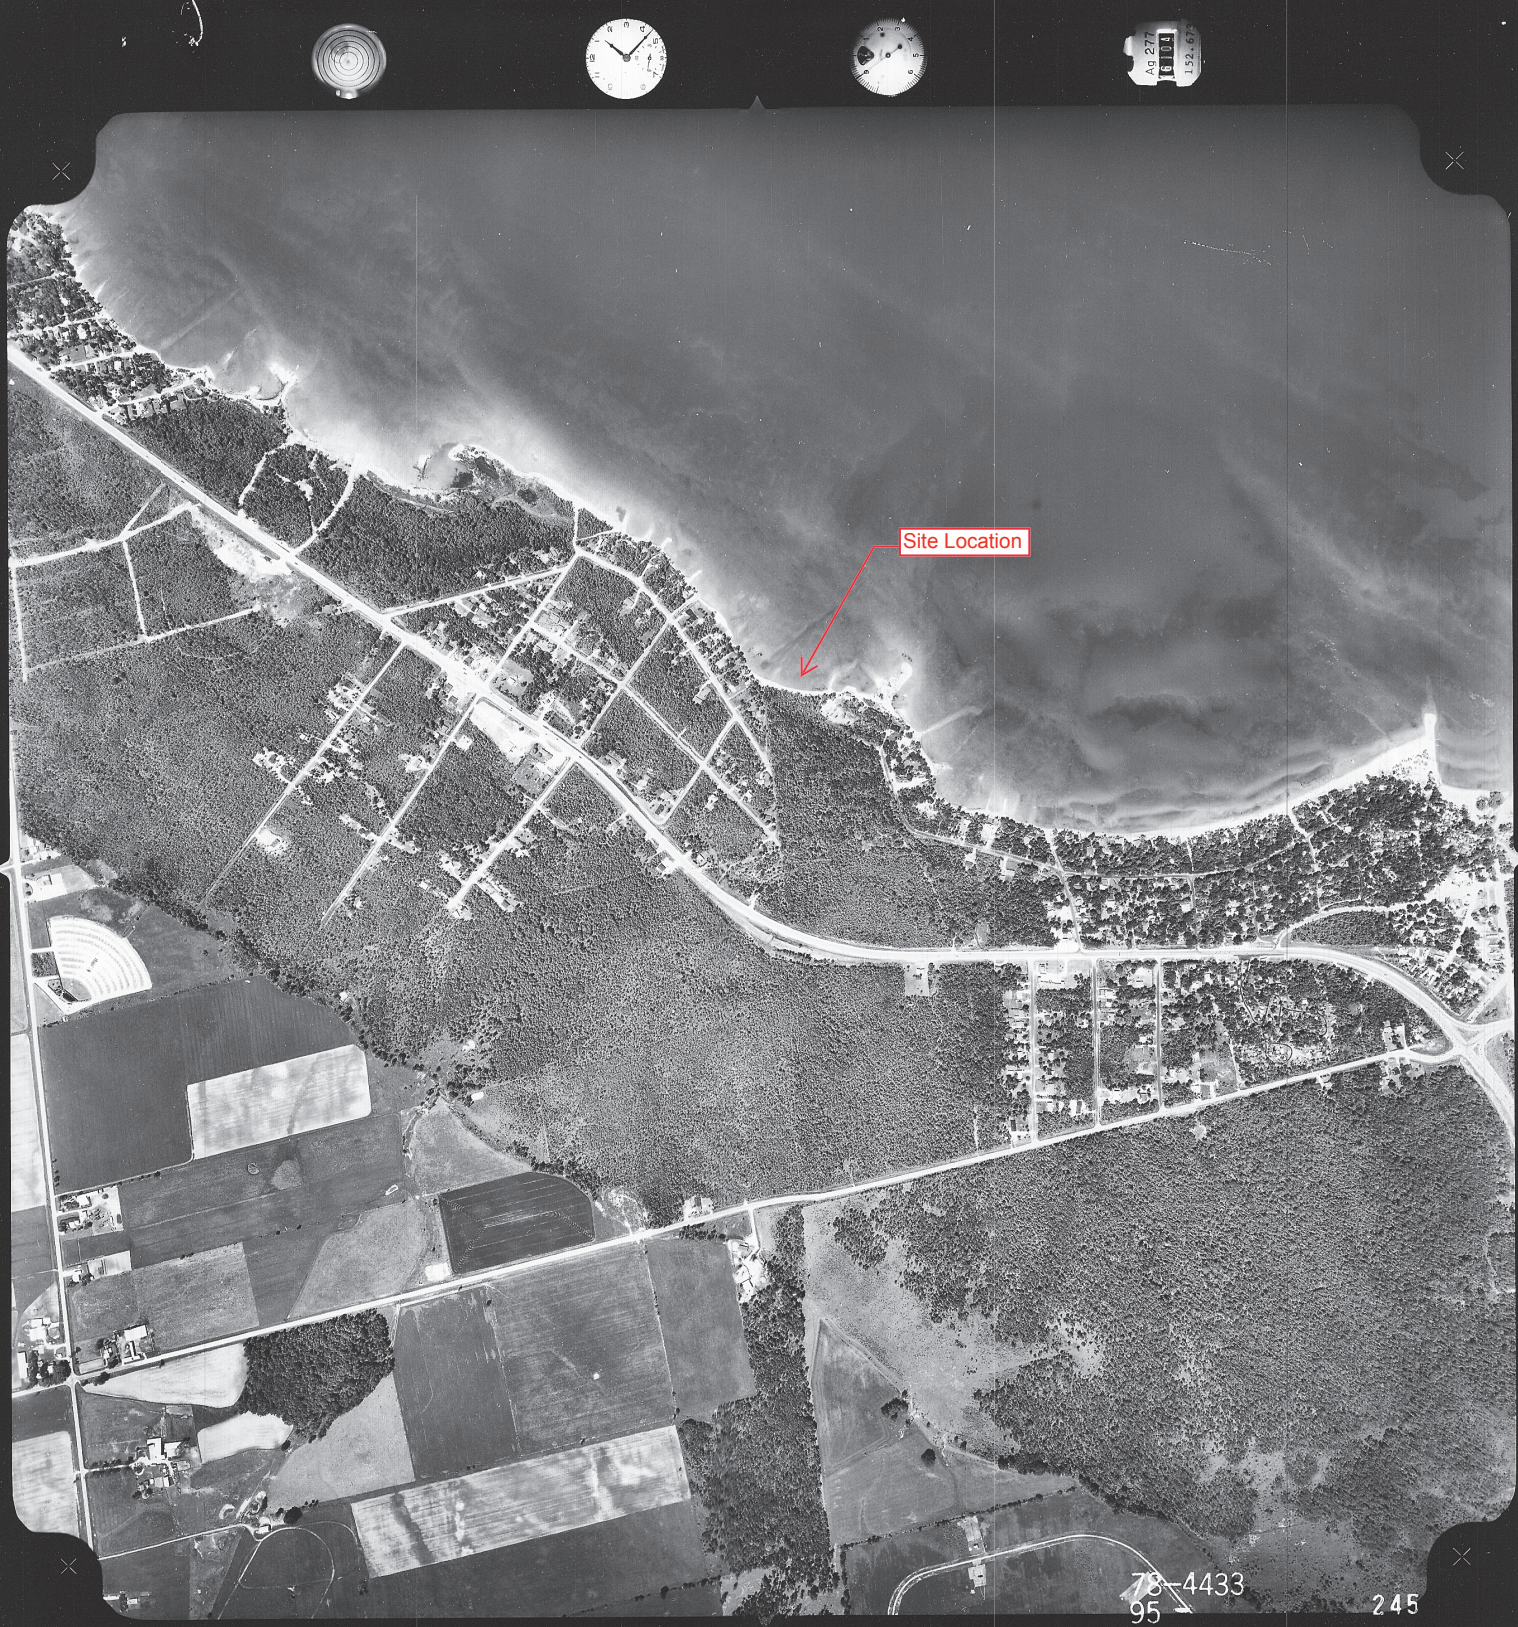
Site Photo - 1978

The subject sand beach is not believed to be a dynamic beach. Historic photos from 1978, 1989, 1997, 2008 and 2016 show an unchanging established treeline at the site location, therefore there is no dynamic beach and no dynamic beach hazard. Historic photos are attached in **Appendix C**.

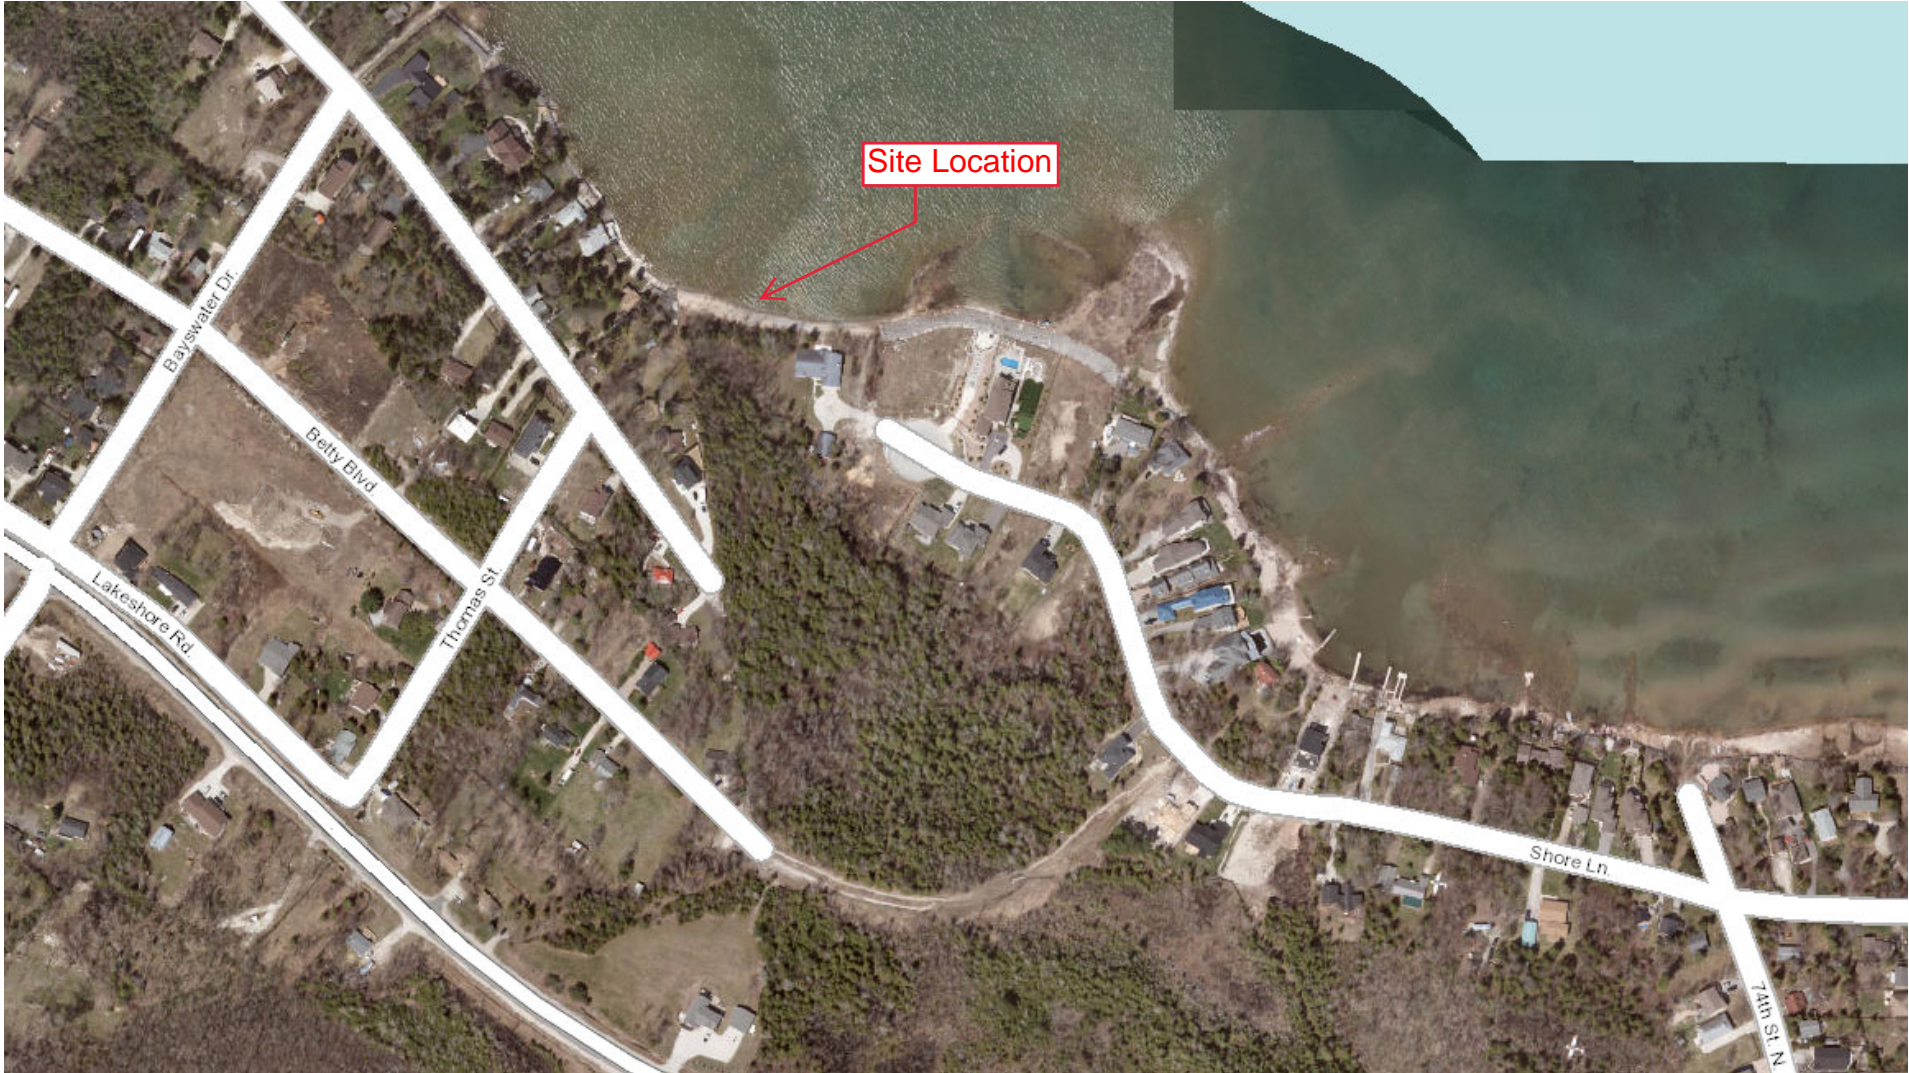
Site Photo - 2016

It is our opinion, based on review of historic aerial photos and available erosion station records, that the average annual recession rate is negligible and there is no erosion hazard at the subject site. The relevant pages from the Coastal Zone Atlas are found attached in **Appendix C**.
