# **WASAGA SHORES SUBDIVISION**

## **Town of Wasaga Beach**

### **Shoreline Hazard Study**

1428420 Ontario Inc.  
November 15, 2018  
CCTA File 116028

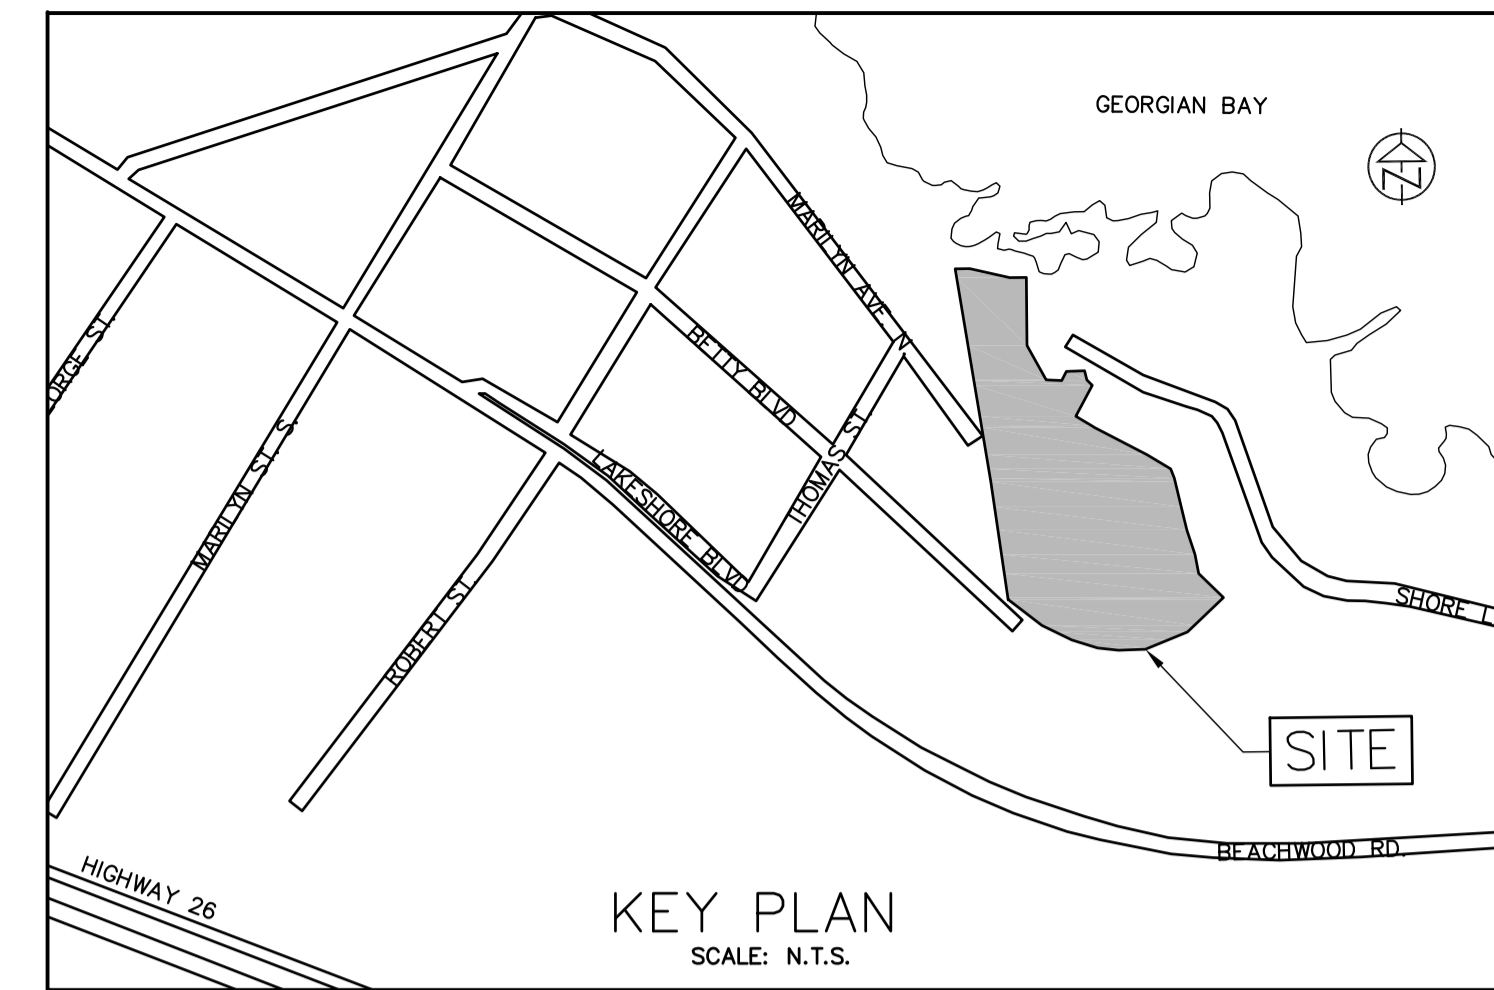
DWG. **HAZ-1**

A 15 m setback, in which the existing shoreline vegetation is preserved, is recommended to provide appropriate protection from hazards associated with ice piling. In addition, a minimum opening elevation of 178.6 m should be applied to all structures.

The hazard limits and proposed setbacks are shown on **Drawing HAZ-1**.

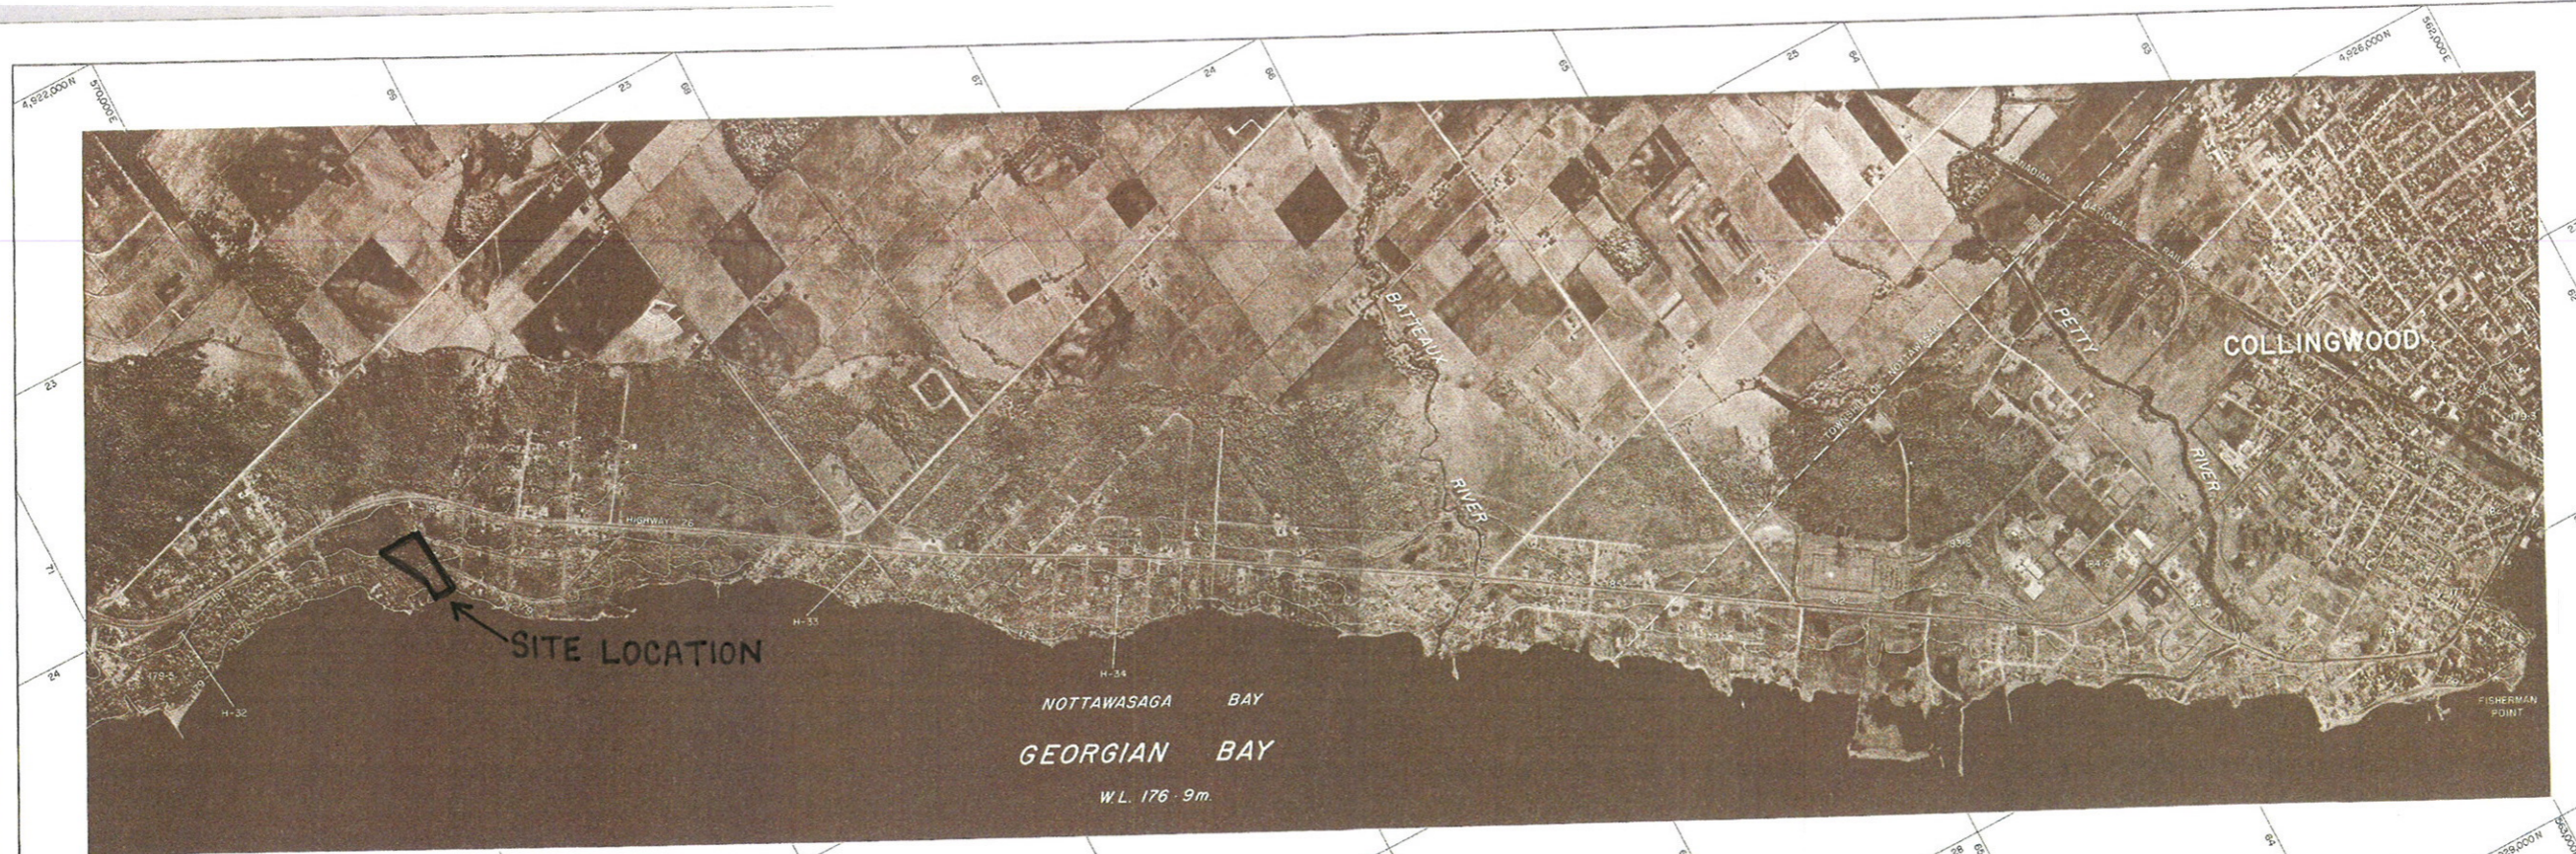
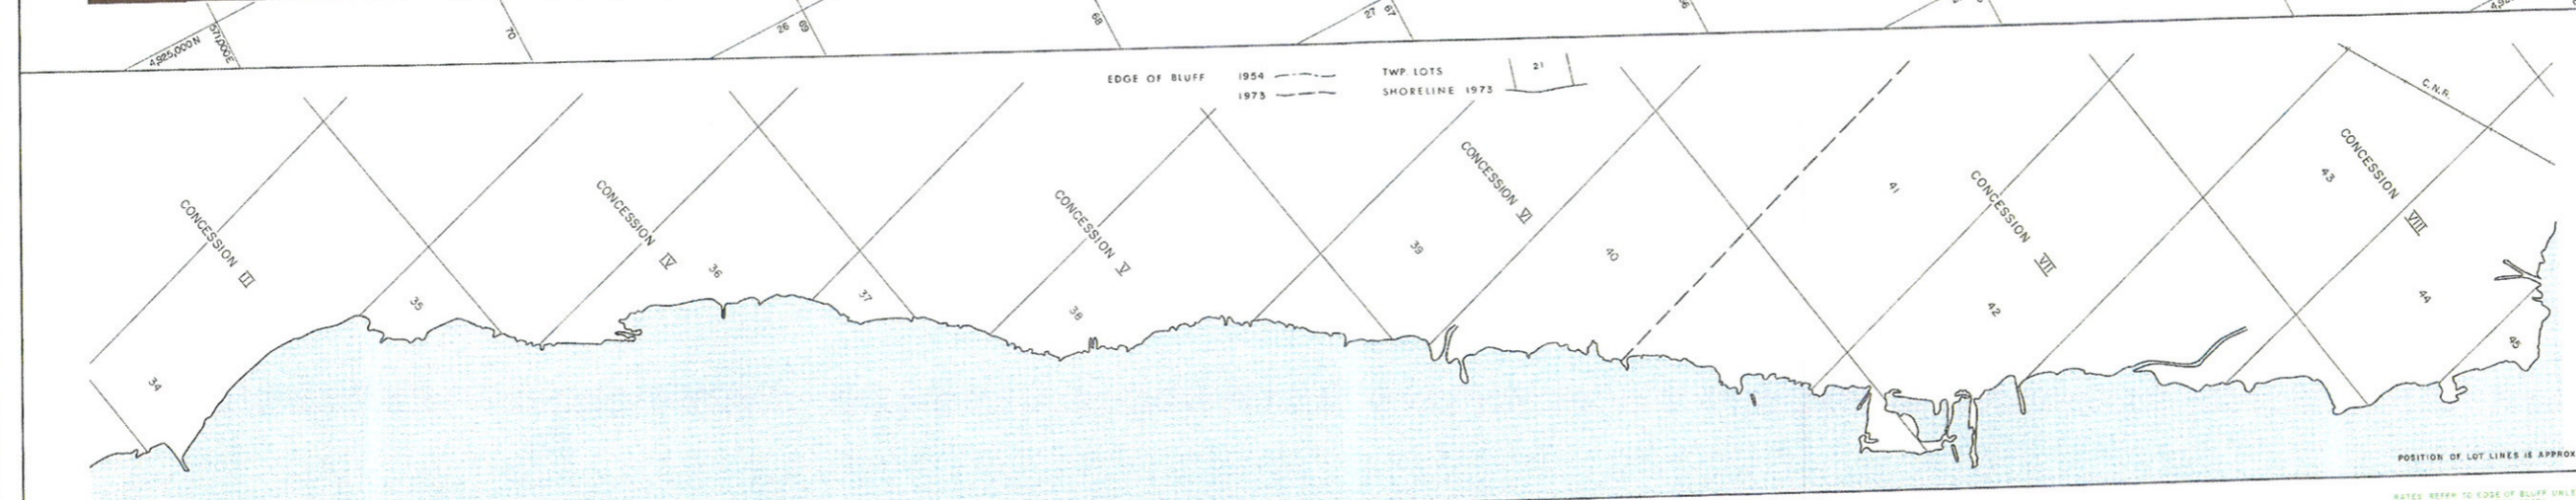
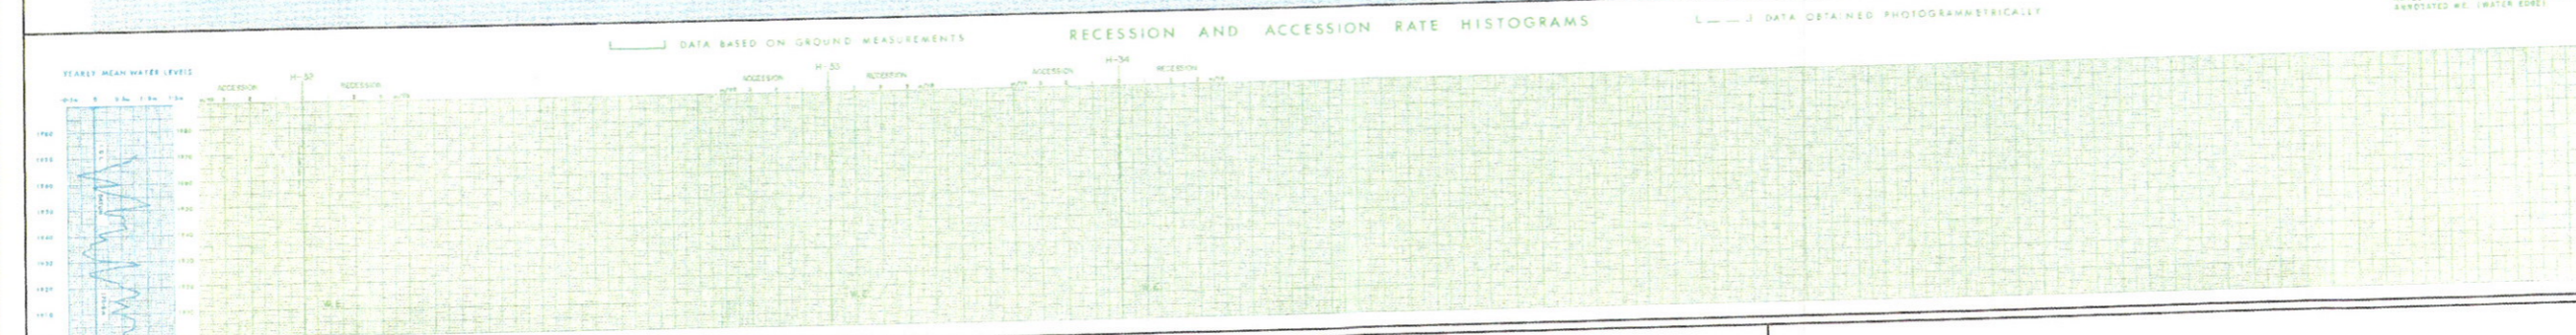
**SHEET 1-19** **LAKE HURON**

Additionally, the Coastal Zone Atlas was used to confirm the likely extent of erosion at the site location. The site is located between erosion monitoring stations H-32 and H-33. The shoreline is described as a beach or dune complex, with permanent residential land use. No shoreline damage due to erosion is described at the site location.
